**NASA CONTRACTOR
REPORT**

NASA CR-1846

**THE EFFECT OF COMPOSITION ON
THE MECHANISM OF STRESS-CORROSION
CRACKING OF TITANIUM ALLOYS IN N_2O_4 ,
AND AQUEOUS AND HOT-SALT ENVIRONMENTS
(Part II)**

Prepared by
BATTELLE MEMORIAL INSTITUTE
Columbus, Ohio 43201
for

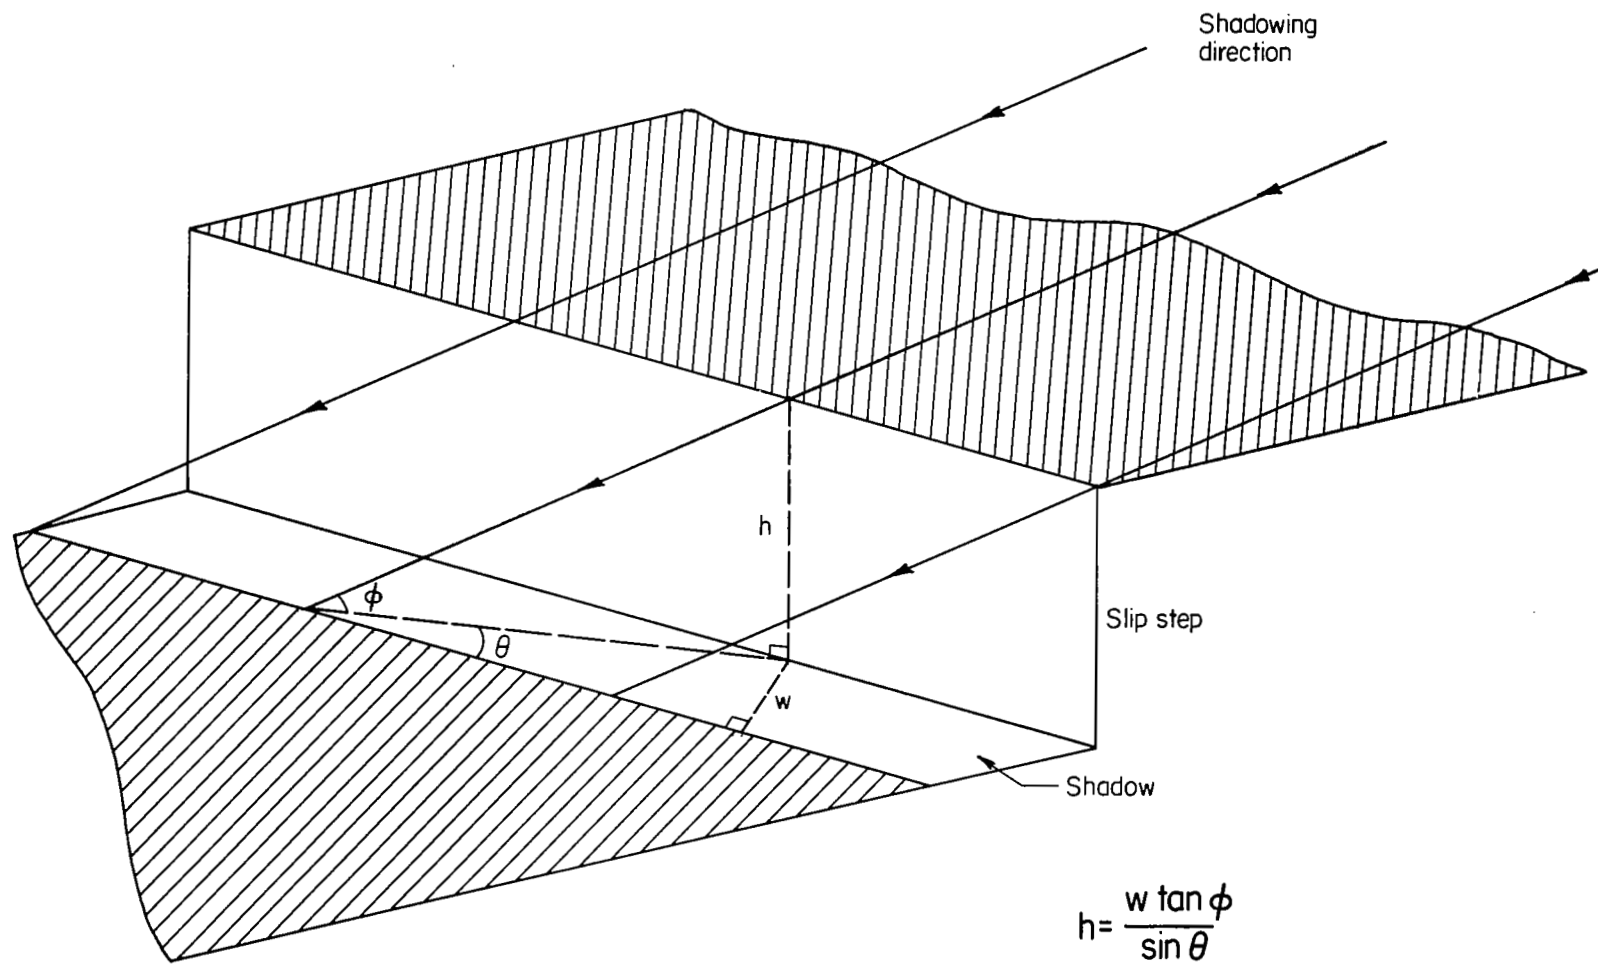
FIGURE 20. CALCULATION OF SLIP-STEP HEIGHT, h , FROM SLIP-LINE WIDTH, w

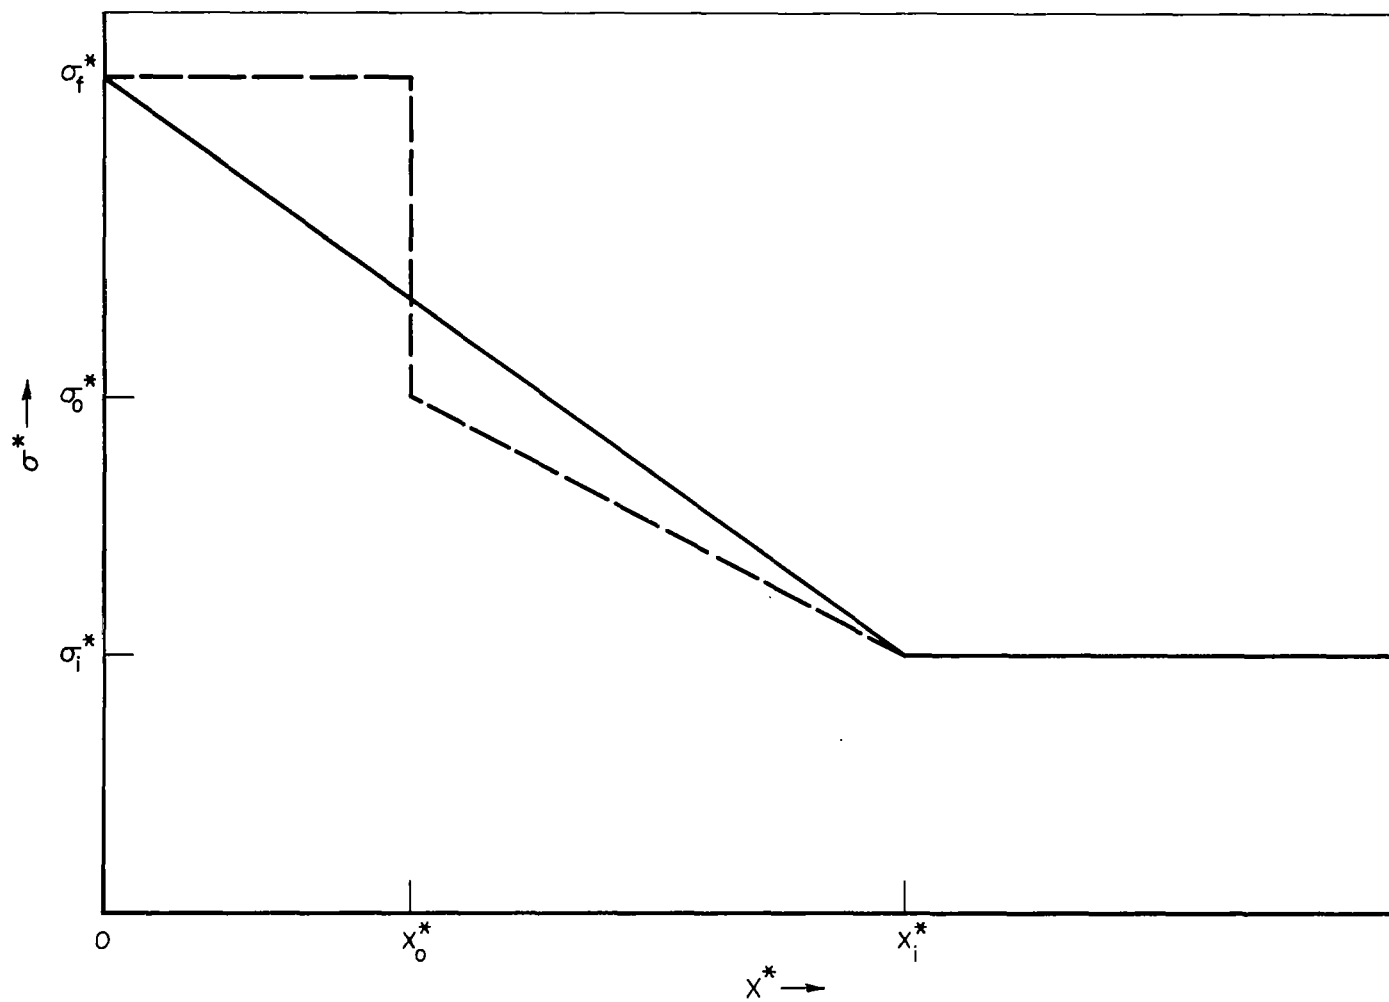
FIGURE 21. IDEALIZED VARIATION IN CLEAVAGE STRENGTH WITH CONCENTRATION OF EMBRITTLING SPECIES

Exactly the same expression is obtained if σ^* is constant and Y is linearly proportional to X^* . In other words, from the crack-velocity data alone it is not possible to determine whether the embrittling species lowers the cleavage strength or increases the yield stress of alpha titanium.

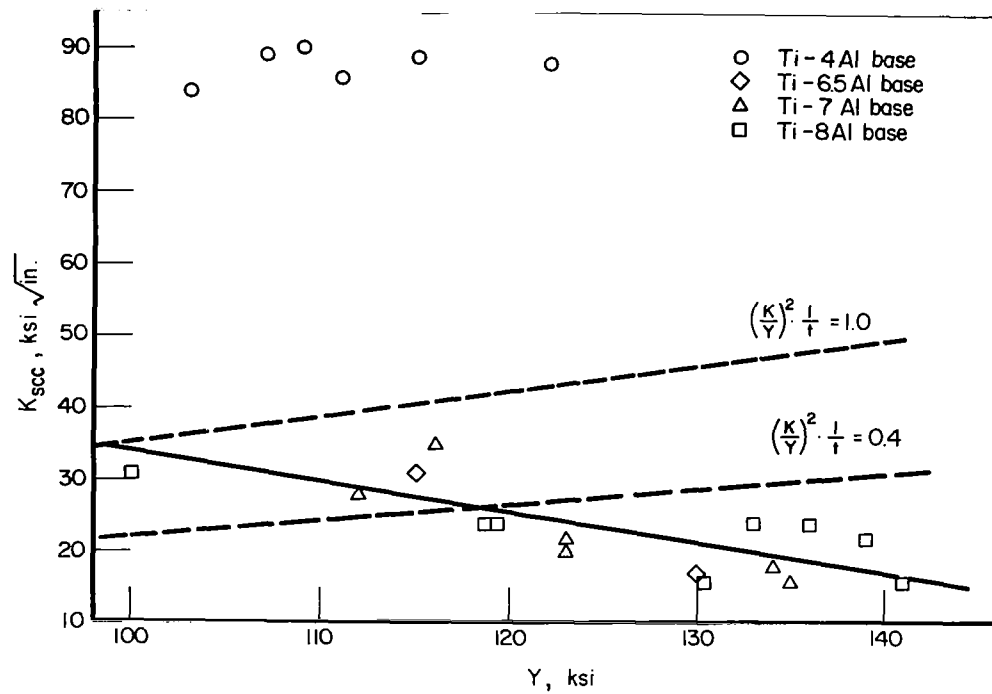
FIGURE 22. VARIATION IN $K_{I_{scc}}$ WITH YIELD STRESS FOR Ti-Al BASE ALLOYS

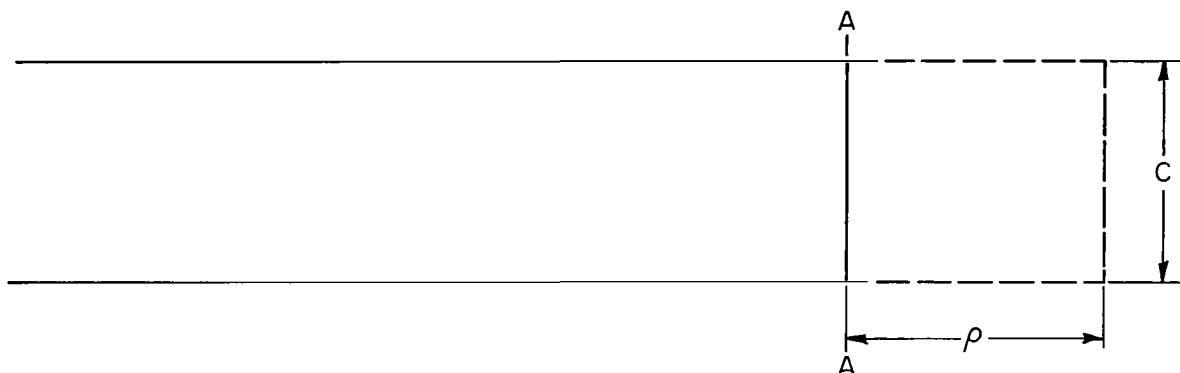
FIGURE 23. IDEALIZED CRACK TIP

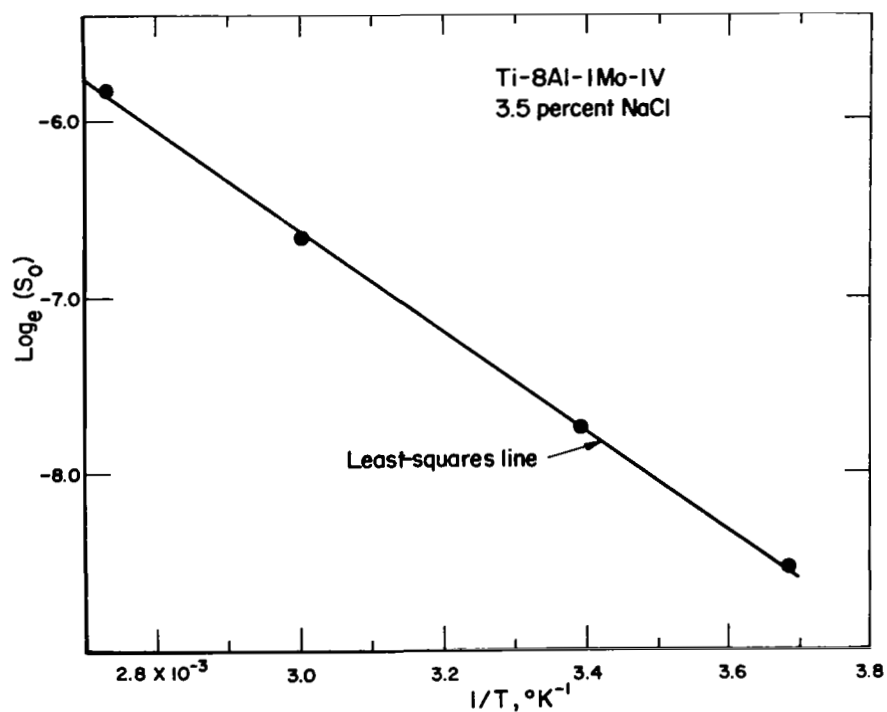
FIGURE 24. TEMPERATURE DEPENDENCE OF S_0

Comparison of Equations (15) and (18) and Equations (16) and (19) suggests that the temperature dependence is different in Stage I cracking from that in Stage II, but the dependence on chloride-ion concentration is the same in both cases. From Equations (14) and (17) it is to be expected that in both cases the observed temperature and chemistry dependences arise solely from the flux term J. The terms X_i^* , X_O^* , and K_{I_X} are essentially material constants which should not vary much with the chemistry of the environment or with temperature over the limited range of temperatures investigated. Thus, the flux of the embrittling species to the crack tip is determined by at least two distinct processes, and the rate-limiting process changes upon going from Stage I to Stage II. Wiederhorn⁽¹⁴⁾ has reported similar behavior for subcritical cracking in ceramic materials. He ascribed the environmental dependence of \dot{a} in Stage I to an activated process at the crack tip, and the dependence in Stage II to a transport rate-limited process. Applying this reasoning to the present case, the rate-limiting process in Stage I cracking would be a reaction at the crack tip, such as dissolution of the embrittling species in the metal, adsorption, or diffusion in the plastic zone, and the rate-limiting process in Stage II would be diffusion of the

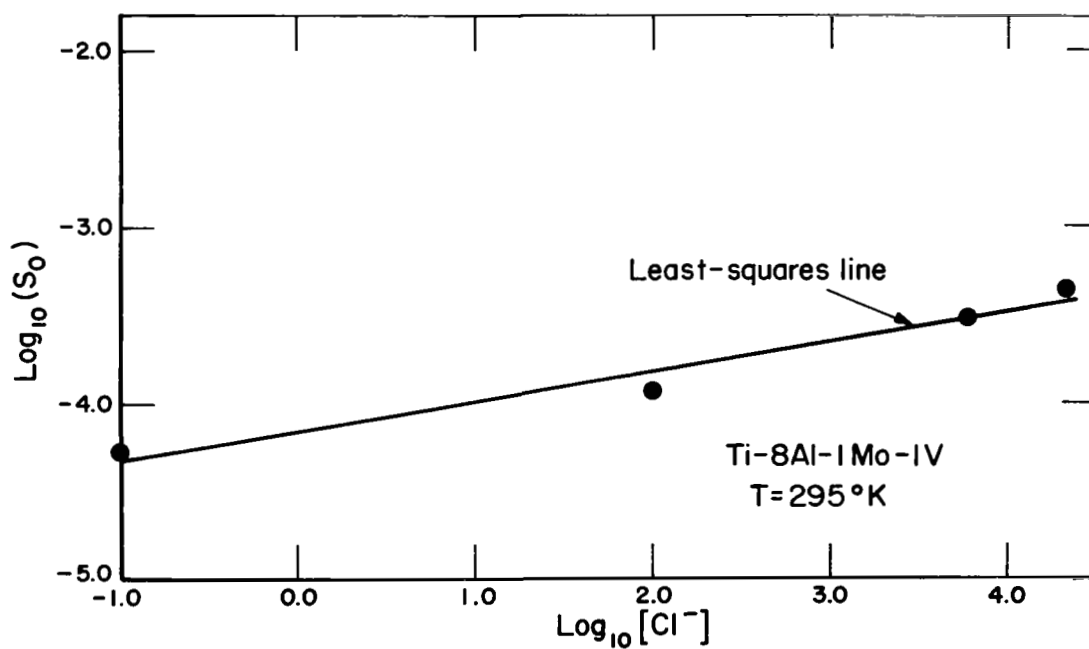
FIGURE 25. VARIATION IN S_0 WITH CHLORIDE-ION CONCENTRATION

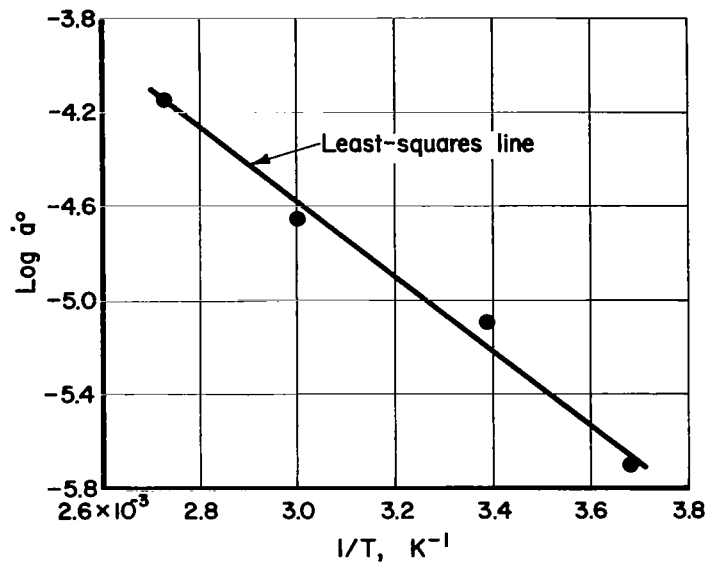
FIGURE 26. TEMPERATURE DEPENDENCE OF a°

embrittling species from its point of origin to the crack tip. Thus, the activation energy of the transport reaction is 3200 cal/gm-mole, and the activation energy of the crack-tip reaction is 5600 cal/gm-mole.

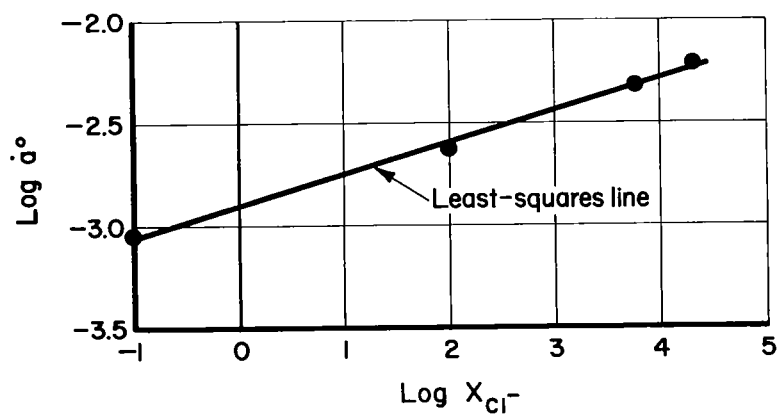
FIGURE 27. VARIATION IN a° WITH CHLORIDE-ION CONCENTRATION

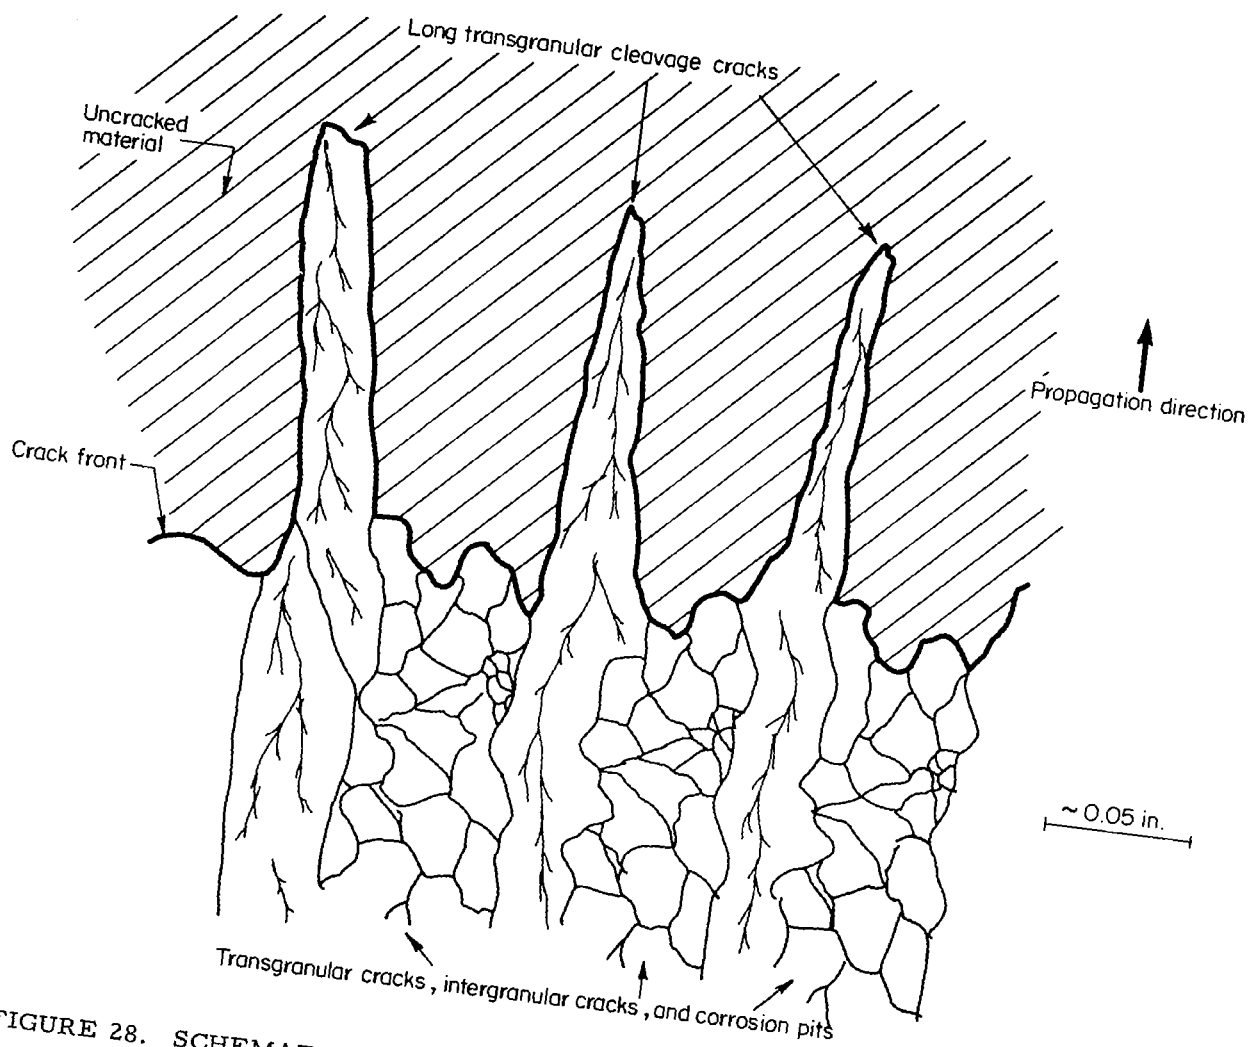
FIGURE 28. SCHEMATIC ILLUSTRATION OF THE FRONT OF A PROPAGATING STRESS CORROSION CRACK DURING STAGE II

The complex shape of the crack front during Stage II crack propagation is illustrated schematically in Figure 28. The crack front consists of the long, narrow cleavage cracks, ("fingers"), which are separated by regions of short cleavage cracks, intergranular cracks, and corrosion pits. This last region of the crack front probably lies behind the long cleavage cracks and offers some resistance to crack extension. It is difficult to comment any more precisely on the propagation of a crack with such a complex geometry. However, these results illustrate two points which are relevant to the interpretation of stress-corrosion experiments.

- (1) When crack extension involves a combination of electrochemical attack, plastic deformation, and cleavage, fractographic observations can be misleading unless a thorough study over a wide range of magnifications is made. In the present studies, just about every conceivable type of fracture mode could have been reported as "typical" if a sufficiently small area had been examined.
- (2) It is not very meaningful to relate the macroscopic applied stress intensity to the conditions at the tip of a crack with an irregular crack front such as that shown in Figure 28.
